INTRODUCTION

I. Tank 4: A Chart MVE Cryopreservation Tank

II. The Defect in Tank 4

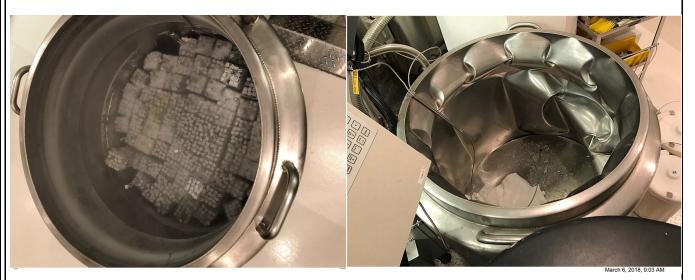
- 5. The cracked weld also triggered an implosion of the tank's inner vessel, as the liquid nitrogen that was sucked into the vacuum space transitioned to gaseous nitrogen and exerted pressure

on the inner vessel's walls. That is why the lid of the tank was difficult for PFC's embryologists to remove. The imploded tank is shown below, on the right:

Imploded Tank

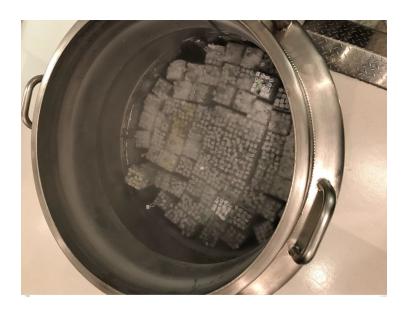
- 16. The tank consists of the outer vessel seen above, an inner vessel that can be used to store eggs and embryos in liquid nitrogen, and an insulated vacuum layer that separates the two vessels and prevents heat transfer from the surrounding environment.
 - 17. The tank's inner vessel is shown below:

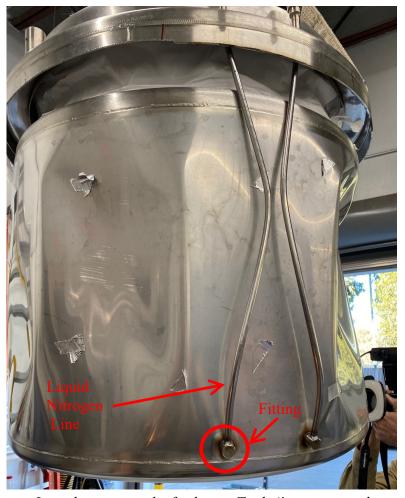
Liquid nitrogen tube feeds into Tank 4's inner vessel

- 23. Tank 4 was only six years old when its vacuum insulation suddenly failed. The reason for the failure was a defective weld near the bottom of the tank's inner vessel.
- 24. Tank 4 was manufactured with a metal tube that is used to refill the tank with liquid nitrogen. The tube ran from the top of the tank, down through the vacuum space between the inner and outer vessel, and then into the inner vessel near the bottom of the tank.
- 25. The picture below was taken after the outer vessel of Tank 4 was removed. The liquid nitrogen tube is on the left and the red circle shows where it connects to the inner vessel through a fitting.

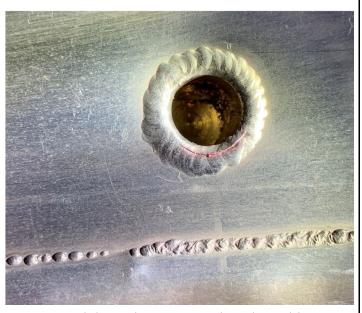
The image on the right is the same weld, this time after using Magnaflux Spotcheck 27. liquid dye penetrant. The fact the red dye penetrant remained after the surface was wiped clean is indicative of a crack.

Red dye indicates a crack in the weld

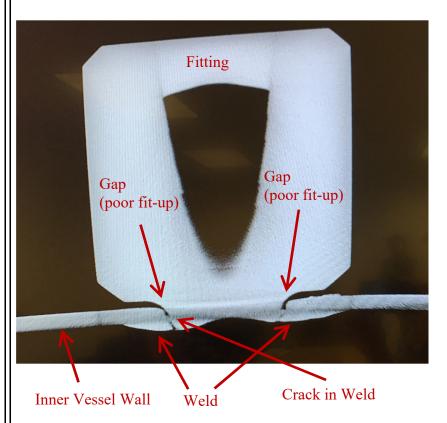
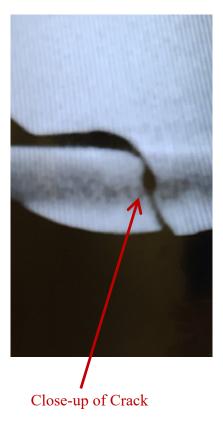
28. The presence of a crack was further verified through CT scans of the weld, shown below. The image on the left is a cross-section where the fitting connects to the tank's inner vessel and the image on the right is a close-up of the weld. The CT images shows a clear crack through the weld.

29. The CT scans also indicate why the weld likely failed. The weld was very thin in the area of the crack—only a fraction of the thickness of the tank wall.

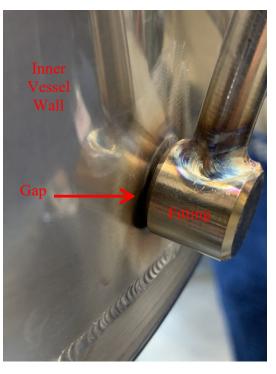
30. In addition, the fit between the inner vessel wall and the fitting was poor. The weld should have fused together the entire edge of the inner vessel and the fitting. But the poor fit left an excessive gap—as shown in the CT image and in a close-up of the fitting below.

- 31. As a result, the weld was unable to withstand the stresses that occur in normal operation of the tank, such as when liquid nitrogen flows through the tank's fill tube and causes the rapidly cooling metal to constrict and place stress on the weld. Eventually the weld cracked.
